Form Number 348
 USGS Quad PLTH
 Area(s)

Town Kingston

Address 38 Crescent Street

BUILDING FORM

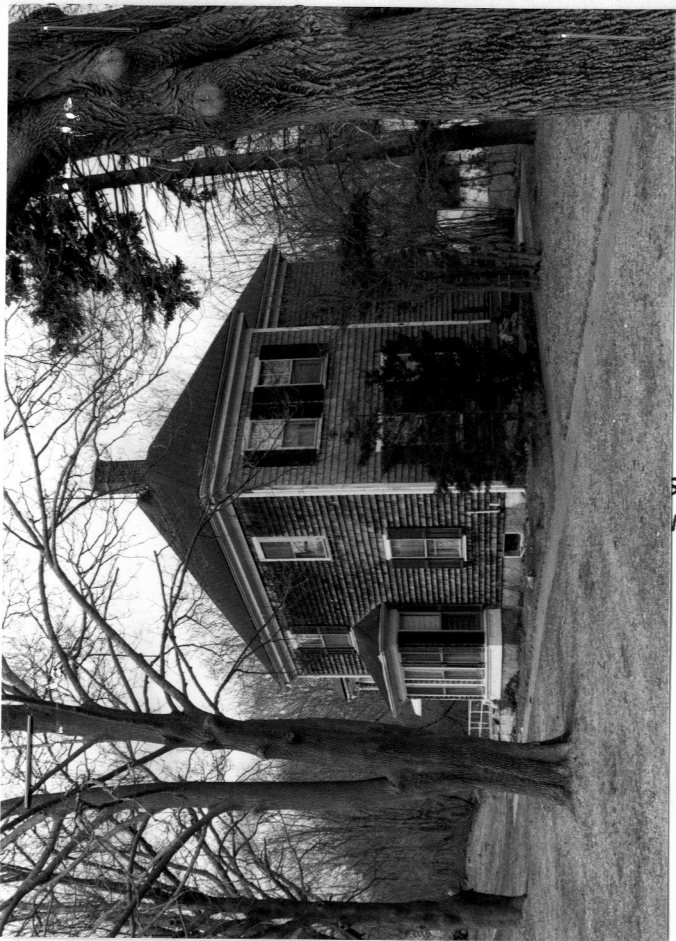
The residence at 38 Crescent Street was built c.1850. This 3x3 bay, wood frame, 2 story building sits on a granite rubble foundation. The building is clad with wood shingles. The hip roof is covered with asphalt shingles. A brick chimney pierces the roof at the center ridge. The entrance is off-center and contains an early 20th century wood door with a large square glass pane in the upper section. The windows contain 2/1 sash with flat surrounds. The cornerboards are thin and flat. the cornice is boxed with an extended overhang. A bay window projects from the first floor, west elevation. A rear ell is constructed with similar materials.
