Town Kingston

Address 202 Main Street

BUILDING FORM

KIN. 440

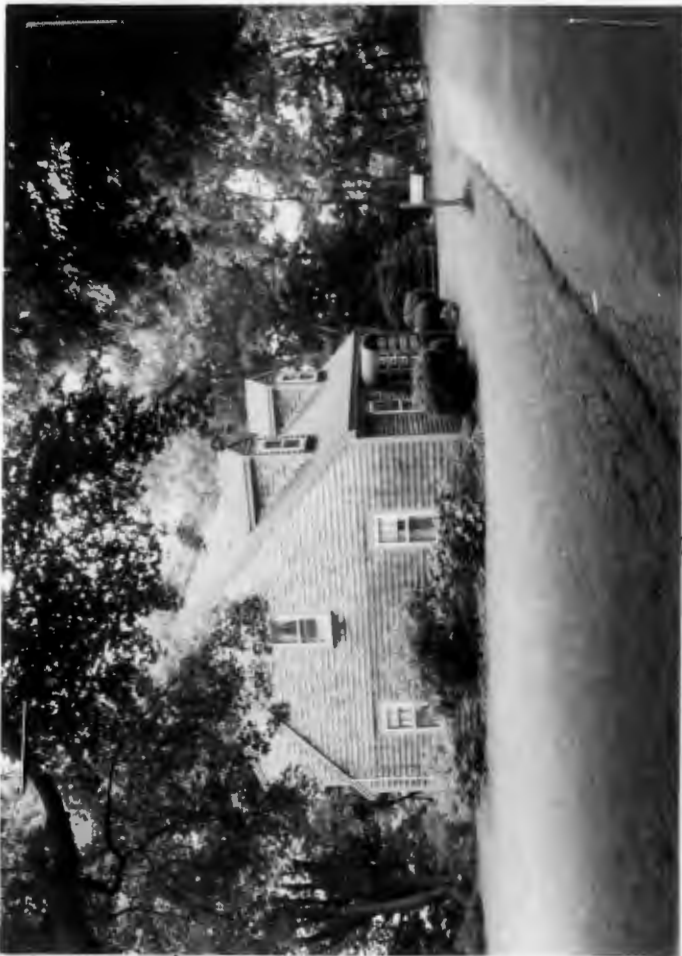
The residence at 202 Main Street was built in 1938 as a cape with a side gable roof. This 3 x 2 bay, wood frame, one-and-a-half story building is rectangular in plan and sits on a concrete foundation. The building is clad with wood shingles. The side gable roof is covered with asphalt shingles. Two single dormers pierce the roof on the front and a shed dormer runs across the rear of the house. One brick chimney is located in the center of the house. The center entrance contains a wood panel door with a plain surround. An arched trellis protects this front entrance. The windows contain 6/6 wood sash with flat surrounds. A bay window protrudes from the side of the first floor. The cornerboards are thin and flat. The cornice is thin with a shallow molding.

A side ell, built in 1992 is attached to the side of the house and is of similar construction. An attached shed is also part of this addition.
