Recorded by Deirdre Brotherson
 Organization Kingston Historical Commission
 Date (month/year) March 2002

s number _____ USGS Quad Plymouth Area(s) B Form Number KIN.444
444

Town Kingston

Address 229 Main Street

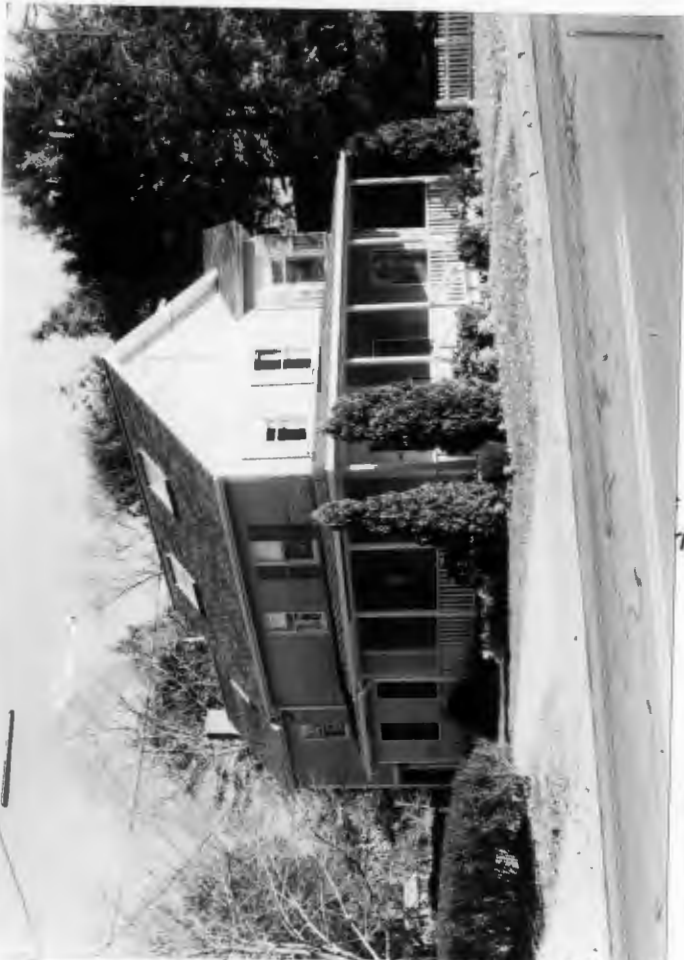
The residence at 229 Main Street was built in 1900 with a front gable roof. This 3 x 4 bay, wood frame, two story building is rectangular in plan and sits on a brick foundation. The building is clad with wood clapboards. The front gable roof is covered with asphalt shingles. A shed dormer and skylights pierce the roof slopes. One brick chimney is located on the rear of the house. The entrance contains a wood door flanked by half sidelights with wide molded surround. The windows contain vinyl replacement 1/1 sash with flat surrounds. The cornerboards are thin and flat. The cornice is thin with a shallow molding. The building has a one story wrap porch across the facade and side of the building. The porch has a shed roof supported by square posts with a balustrade. A bay window projects from the side of the building. A two story 1x1 bay projects from the front corner at an angle. The windows in this bay have colored glass transoms. A two story ell of similar construction is at the rear of the building.

This building has had significant remodeling and much of the original exterior materials have been changed.

This house is one of several residences built on Main Street in the early 20th century. The house has been heavily remodeled on the exterior and although it can be visually identified as an early 20th century building, it has lost much of its historical architectural integrity.
