*Kingston Old Burying Ground
Preservation Master Plan*

On Monday, January 6, 2020 I visited Old Burying Ground in Kingston to perform a structural assessment of tombs A-2, B-2, C-2, D-2 and E-1. The following is a summary of my findings and initial recommendations.

**GRAVESTONE/MONUMENT
CONDITION ASSESSMENT
REPORT**

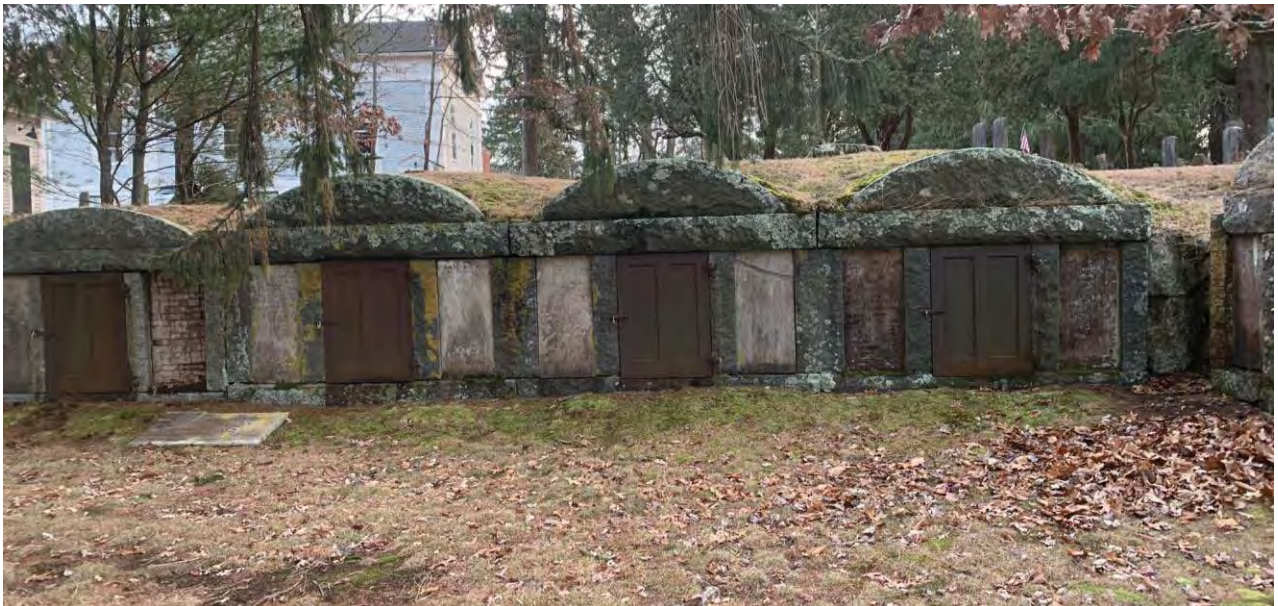
STRUCTURAL DESCRIPTION

The five mound tombs are located at the northeast corner of the burying ground, with E-1 facing the east and the other four facing north. All are constructed with mortar-parged fieldstone comprising the back and side walls of the tombs and an assemblage of dressed granite door jambs and brick infills comprising the front walls, landing on a cut granite sill and stone rubble foundations.

The roofs are constructed with earth-covered rough-faced side-dressed granite slabs, with cut stone lintels heading off the walls, capped with rounded cut granite pediments. Each of the front door openings has a cast iron door, hung from forged iron pintles and locking hardware embedded into the jambs. All of the tomb entrances except tomb D-2 are flanked with inscribed marble plaques.

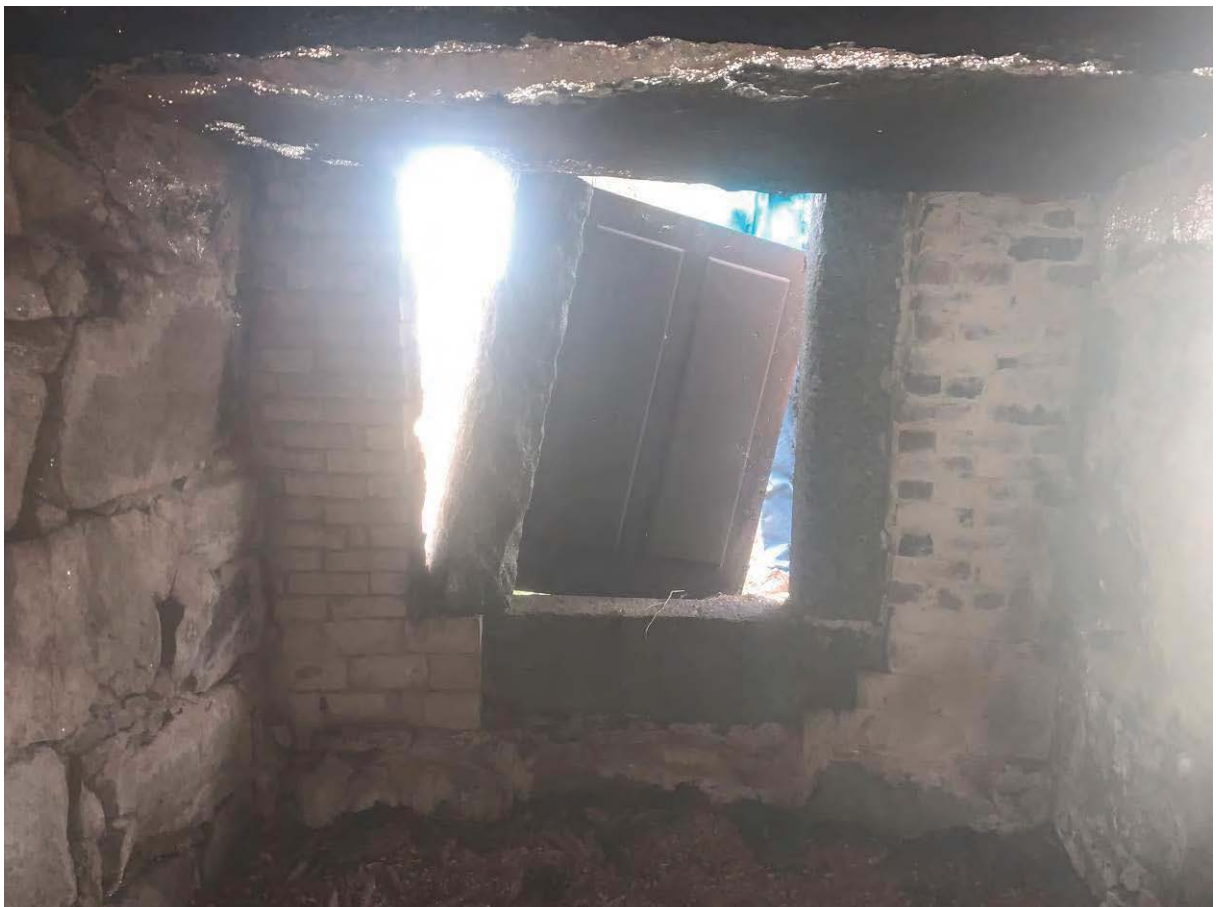
Tomb A-2-

- The interior stonework that forms the side and back walls is in materially good condition, with a few exceptions:
- There is a thin vertical crack running through the east side wall, which is probably due to ground settlement or frost heaving, *and should be pointed and injected grouted with compatible products. Consideration should be given to burying rigid insulation along the wall, which would reduce the incidents of frozen subgrade and shifting in the walls, however the archaeological implications doing this should also be considered.*
- There is a small area at the front lower corner of the west side wall where the mortar parging is spalling and the joints are eroded. *Softened material should be removed and the surface re-parged.*

- The roof slabs are sound and the joints between them intact.
- There are narrow gaps between the front wall and the east and west side walls that appear to have been caused by the front wall shifting outward, however the front wall remains generally planar and plumb. *After repairs are made to the front wall the gaps should be filled with a compatible mortar or grout.* Some of the movement may also be from the effects on frost lensing in the underlying soil, *which can be treated by burying rigid insulation along the front of the wall.*

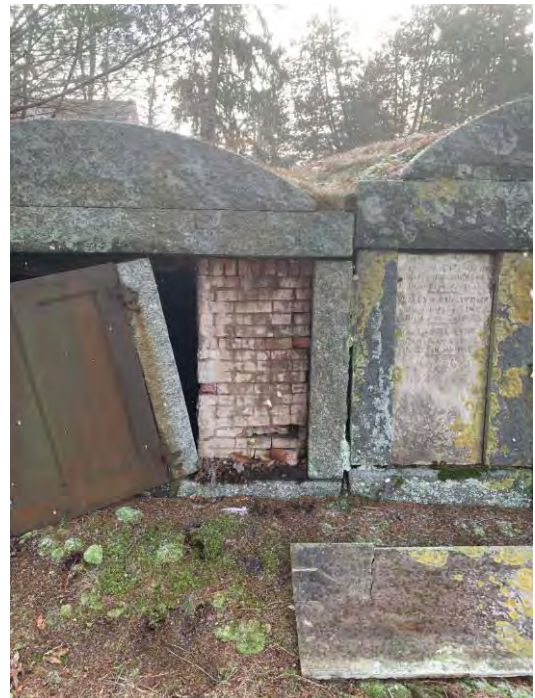
- The mortar bed joints below the stone lintel that crosses the front of the tomb are all cracked and have widened, and one can see that the iron pins at the tops of remaining jamb and corner stones have also failed. *We recommend that the remaining pins be cut along the bed line and the lintel stone and capstone be lifted off. This may destabilize the remaining front of wall and it should be laterally braced during this operation to prevent movement. Any loose bricks should be removed and re-set or replaced and the pins drilled out and replaced with new stainless steel. Then stone lintel and cap should then be bedded back into place and mechanically restrained with hidden ties to the sugrade tomb to prevent outward movement. Consideration should be given to reconstructing the front wall in its entirety, given the possibility that the pins at the bottoms of the remaining jamb and corner stones are also rusted away, although the joints at the bottom of these elements have not appreciably widened.*

- The marble plaque that was adjacent to the west jamb fell off the front of the tomb when the jamb stone tilted away and broke into two pieces. *The plaque should be repaired and reapplied with restraining clips in the corners and the collar joint behind filled with a compatible grout.*
- The fallen plaque revealed significant deterioration in the brick back-up construction, where the mortar joints have failed and the bricks have moved apart and expanded the wall through freeze-thaw cycling. *The brick back-up wall on the west side of the door should be dismantled and rebuilt.*
- The small stone retaining wall at the east side of the tomb has shifted and bulged *and should be rebuilt. Consideration should be given to burying rigid insulation along the front of the retaining wall.*

- *General: Until a comprehensive restoration plan is able to move forward that at least includes all of the items noted above, the front wall should be made secure until it can. We recommend that the fallen plaque be placed in safe storage (or in the tomb's interior) and that the door and jamb stone be wedged back into position and locked. A wooden brace or barricade should then be added against the front wall.*

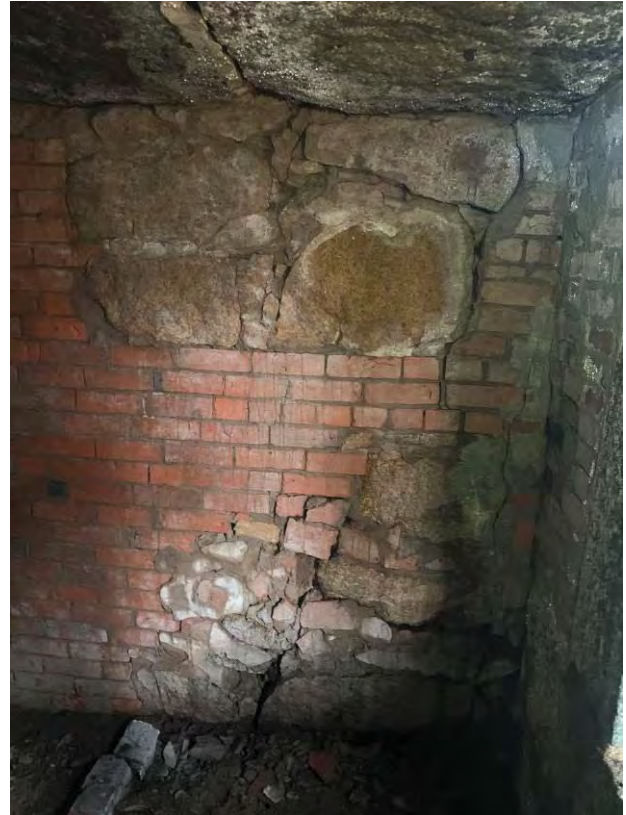
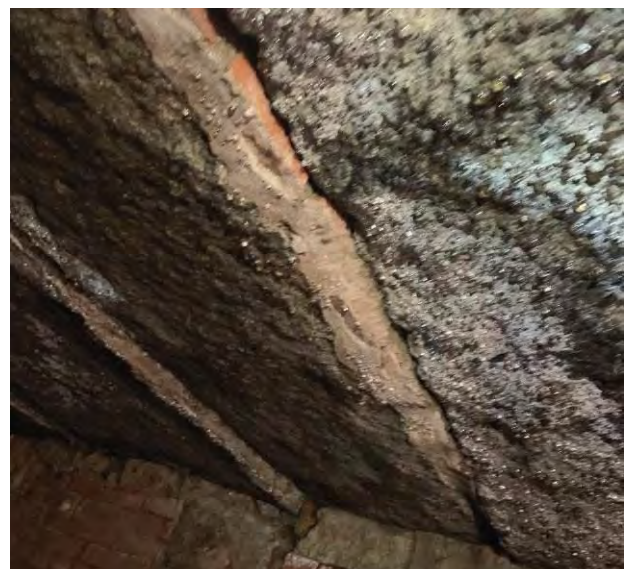
- There are open gaps between the stone roof slabs that suggest the slabs have spread apart and the front roof edge has moved northward. This forward movement has tilted the front wall forward and is likely responsible for the vertical crack along the front edge of the west wall and the open hole at the upper front corner of the east wall. The forward spreading of the roof is likely caused by water soaking into the mortar joints and expanding them through freeze-thaw deterioration. *The roof should be exposed from the top and the joints cut out and repointed. Membrane strips should be laid over the tops of the joints to protect them from rainwater infiltration and*

then the grassed soil covering should then be replaced.

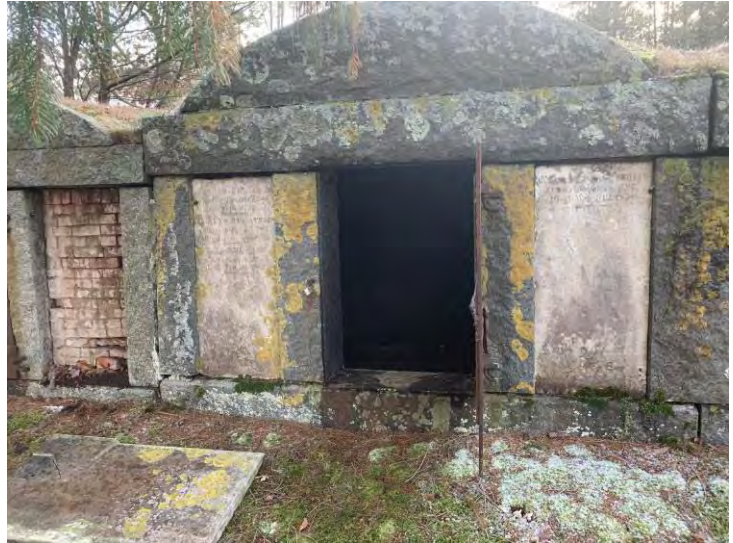
- All of the mortar joints between stones of the front wall are cracked and expanded, and we recommend that the wall be carefully dismantled and reconstructed, incorporating stainless steel pins in place of the rusted iron ones. The underlying rubble stone foundation should be investigated and if found to be wet-laid and shifted it should be excavated and rebuilt. If found to be dry laid, which is more likely, it should be pointed and injection grouted as recommended above. A hidden tie-back system that anchors the front wall to the back of the tomb roof should be incorporated into the rebuild.

- General: Due to the scattered and evolving nature of the damage and extent of the required repairs, we do not see any one single item that can be addressed as an initial stabilization measure, rather, a comprehensive restoration of the tomb should be undertaken on at least a tomb-by-tomb basis.

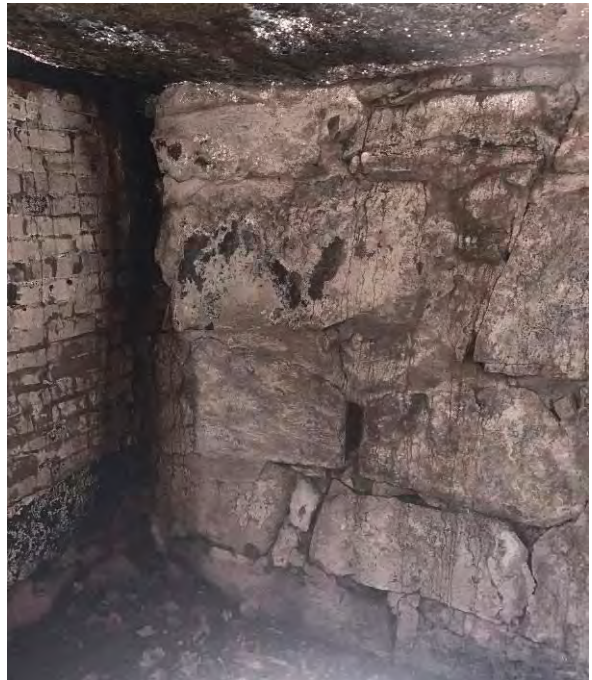
Tomb C-2-

- The interior stonework that forms the side and back walls is in materially good condition, however there are gaps between the north ends of the east and west side walls and the back of the front wall that are up to 4" width. These have been caused by the forward movement of this wall as well as potential frost effects. As noted below, this wall should ultimately be rebuilt.
- There is a small area on the lower center of the west wall that has eroded mortar joints that should be cut and pointed.
- There is also a 4" gap between the top of the front wall and the north edge of the roof, which is otherwise entirely intact.

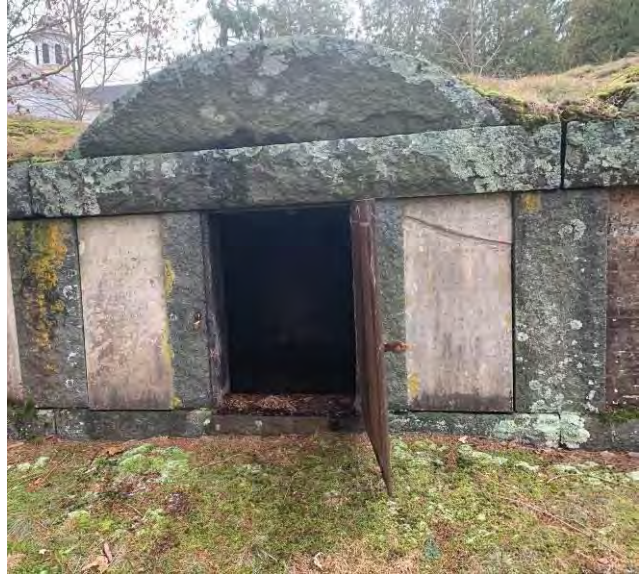
- The majority of the mortar joints between stones of the front wall are cracked and expanded, and *we recommend that the wall be carefully dismantled and reconstructed in its original position. This should incorporate stainless steel pins in place of the rusted iron ones and a hidden tie-back system that anchors the front wall to the back of the tomb roof. Consideration should be given to burying rigid insulation along the outside of the front wall.*
- *General: Due to the scattered and evolving nature of the damage and extent of the required repairs, we do not see any one single item that can be addressed as an initial stabilization measure, rather, a comprehensive restoration of the tomb should be undertaken on at least a tomb-by-tomb basis.*

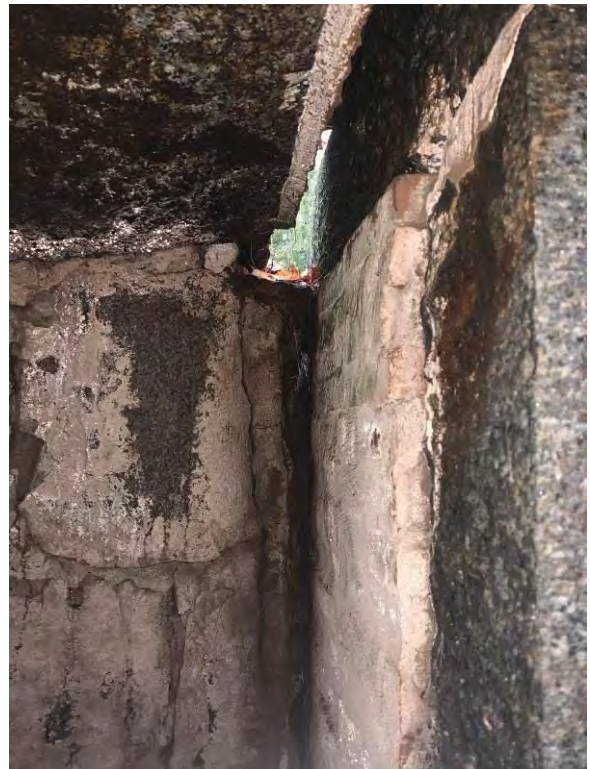
Tomb D-2-

- The interior stonework that forms the side and back walls is in materially good condition except that the north portion of the west wall has eroded mortar joints *and is in need of cutting and pointing.*

- The front wall has tilted forward with respect to the side walls and roof, and there are gaps between these of several inches. At the east wall one can see into tomb #C-2, and at the roof one can look up into the gap and see the underside of the rounded lintel cap and at the west wall one can see daylight. The gap at the west wall is a clean break between the brick backup of the front wall and the stone to the south, whereas at the east wall the front wall makes a short 90-degree return to the south, which has separated from the adjacent stonework. *This gap should be closed by reconstructing the front wall into plumb position. Consideration should be given to burying rigid insulation along the outside of the front wall.*

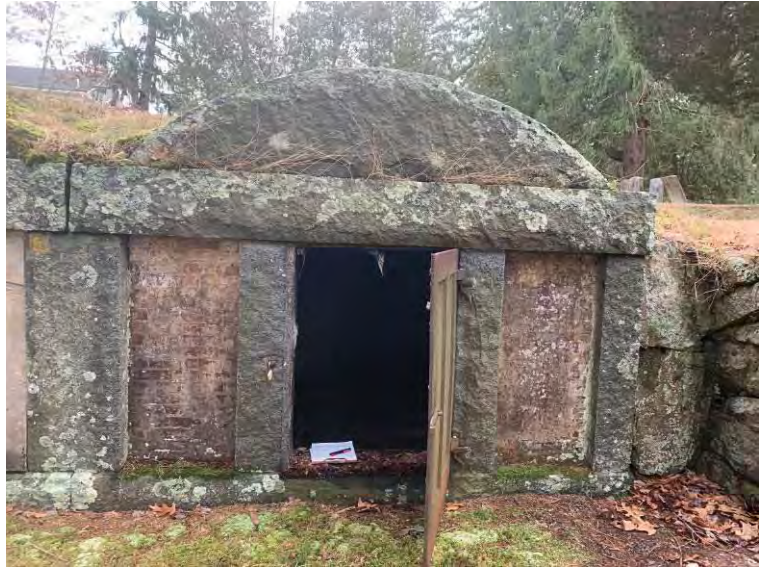
- The lintel and rounded cap have widened joints below them that would suggest that the pins have failed. There is also a gap between the east shared cornerstone (which we have already recommended be re-set) and the exposed brick back-up panel to the west. Because the damage to the front wall appears to be limited to the upper portion, there is the option of re-setting only the upper stones and leaving the lower stones and brickwork to remain in their tilted positions. The

above-noted gaps would be filled with mortared chinkers and/or grout. The challenge with this, however, will be visually blending this forward tilted wall section with the plumb rebuilt sections to the west, as a visible differential frontward shift will remain. *Therefore, we recommend that rebuilding the entire front wall of this tomb to a plumb position. Any reconstruction should incorporate stainless steel pins in place of the rusted iron ones and a hidden tie-back system that anchors the front wall to the back of the tomb roof.*

- *General: Due to the scattered and evolving nature of the damage and extent of the required repairs, we do not see any one single item that can be addressed as an initial stabilization measure, rather, a comprehensive restoration of the tomb should be undertaken on at least a tomb-by-tomb basis.*

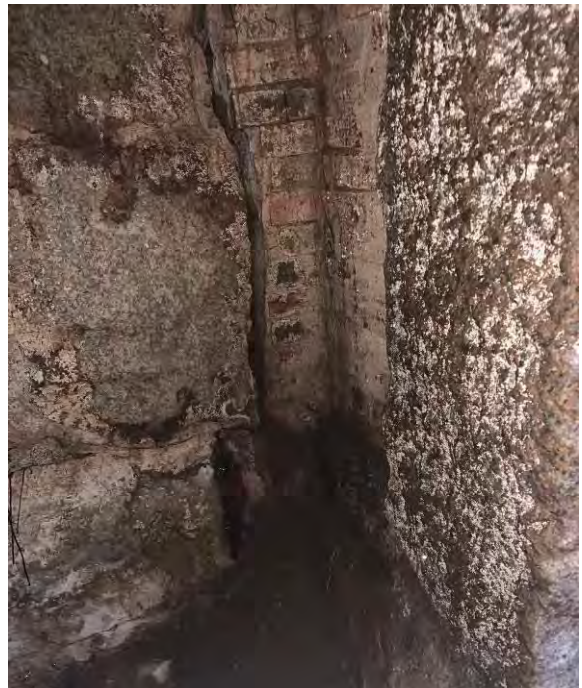
Tomb E-1-

Please note that this is the only east-facing tomb.

- The eastern portions of the north and south side walls have eroded mortar joints and multiple vertical and diagonal cracks running through them. It appears that the stonework had expanded eastward due to freeze thaw cycling and perhaps ground movements. *The front halves of both side walls, which are most likely dry laid with a mortar finished face, should be cut and repointed and then injected with a compatible grout to give them some in-plane tensile and shear capacity.*
- The east wall has short westward returns coming from the brick back-up that flanks the doorway. The returns have separated from the adjacent stone north and south wall construction by up to an inch, due to the frontward movement of the east wall, *which should be rebuilt.*

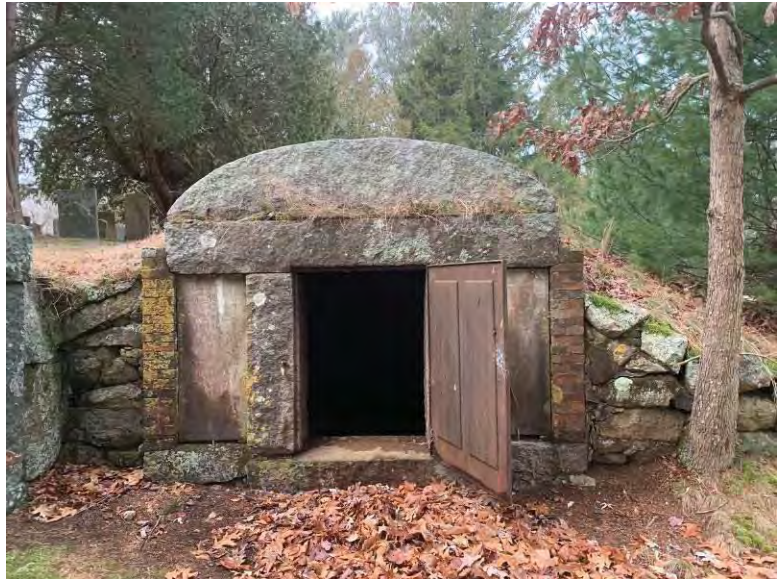
- Because of the majority of the mortar joints between stones of the front wall are cracked and expanded, and *we recommend that the wall be carefully dismantled and reconstructed in its original position. This should incorporate stainless steel pins in place of the rusted iron ones and a hidden tie-back system that anchors the front wall to the back of the tomb roof.*
- The sloping stone retaining wall at the north side of the tomb is shifted and bulged forward *and should be rebuilt.*

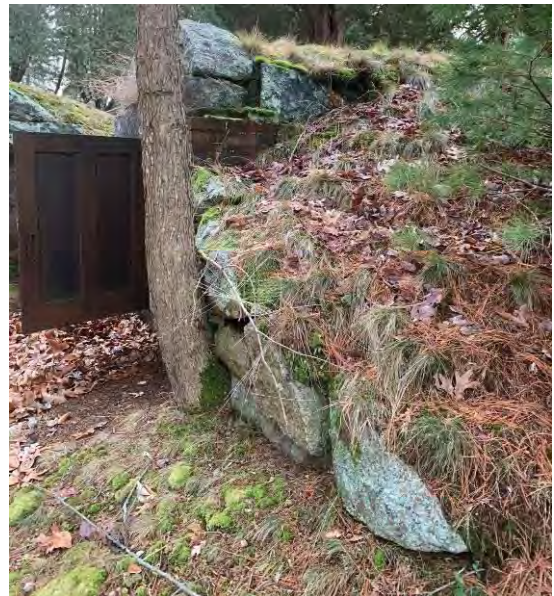
- The L-shaped wall that links tombs D-2 and E-1 has eroded mortar joints *and should be cut and repointed.*
- *General: Due to the scattered and evolving nature of the damage and extent of the required repairs, we do not see any one single item that can be addressed as an initial stabilization measure, rather, a comprehensive restoration of the tomb should be undertaken on at least a tomb-by-tomb basis.*

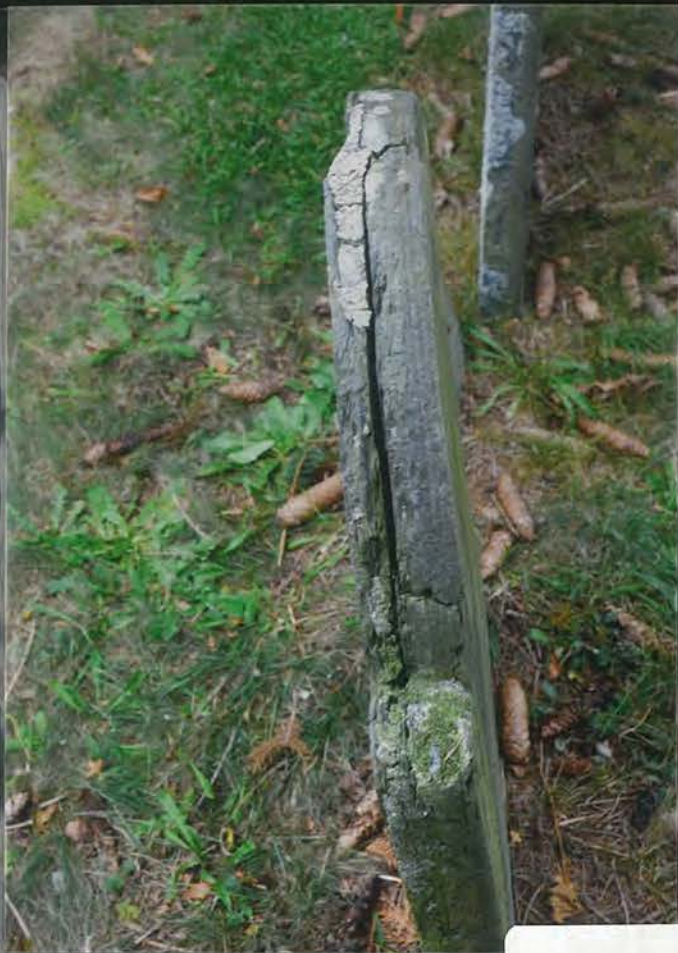
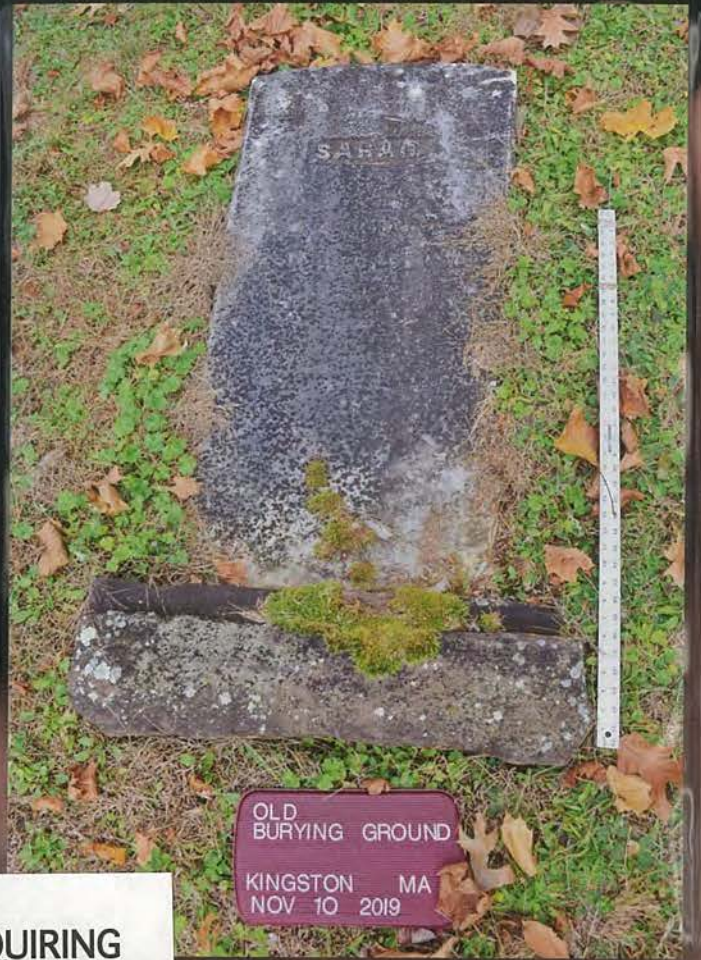
**STONES REQUIRING
CONSERVATION**

OLD
BURYING GROUND
KINGSTON MA
NOV 10 2019

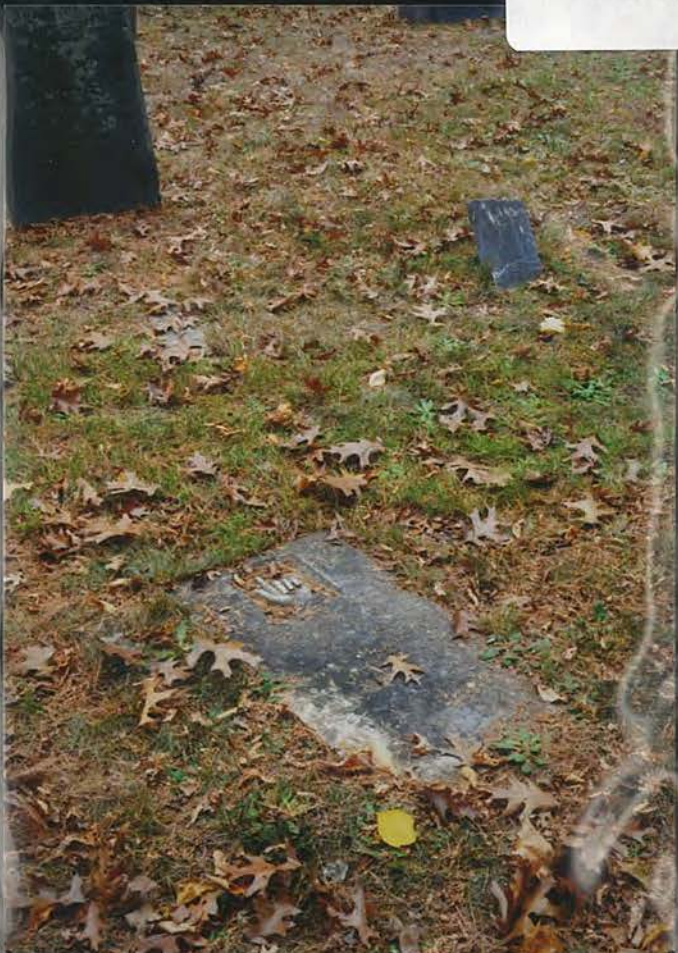
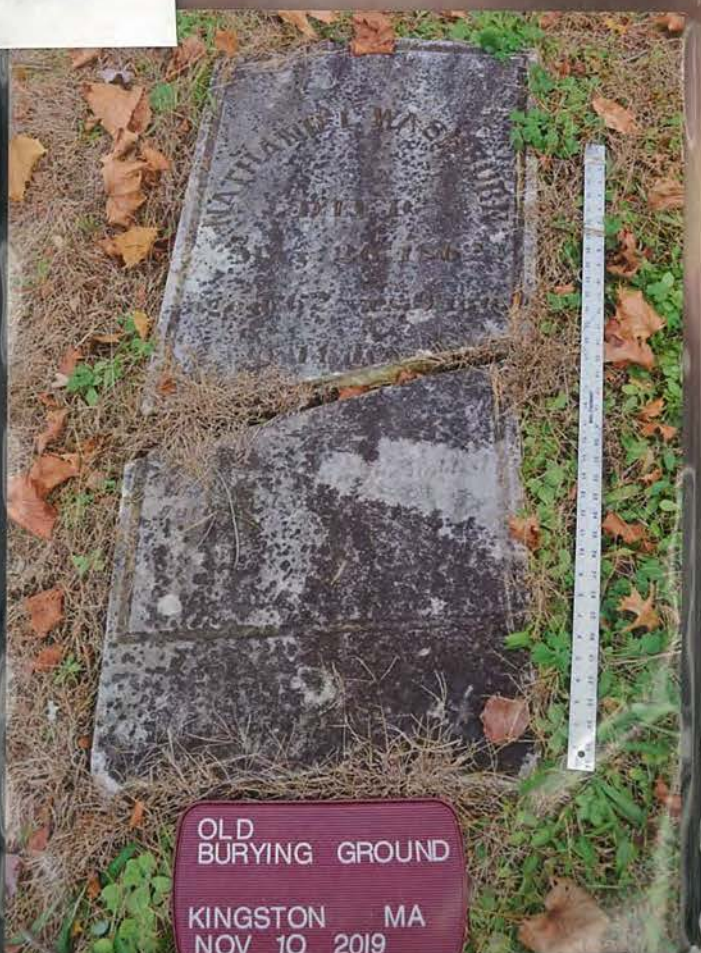
HUNTS PHOTO VIDEO
DSC_0654

Fannin•Lehner GENERAL VIEW WITH
271 Lexington Road STONES REQUIRING
Concord MA CONSERVATION
Old Burying Ground
Kingston MA Nov. 4, 2018
Set: 1 Photo DSC3-0650

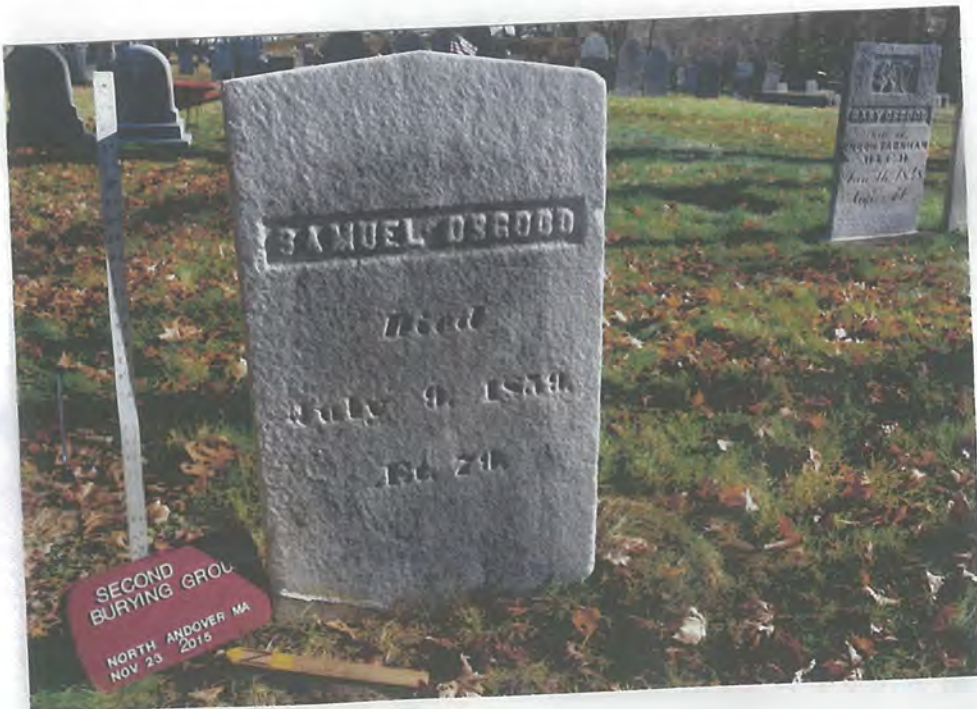
After Photo:

Conservation Notes: 5/13/15- 1) Stone and curved bottom fragment excavated. The hope was a base would be located below grade. No base was found. It was decided to form and pour a new base. 7/15/16- 2) When excavating further, to prepare the hole for a new concrete slotted base, the granite base to the stone was discovered about 10" below grade. 3) When the granite base was cleaned off, it was obvious it could be utilized as it is pretty much intact. The base was observed to be quite rough and clearly never meant to go above grade. It was also seen that is also partially cracked but the thinking is that preference should be given to using the original fabric a chance before going to a new concrete slotted base. 4) Granite base cleaned with D2 Biological Solution, Photo-Flo, and water. 5) Granite base reset level, and plumb, in well-compacted sand and peastone. It was set with the top of the base 5" below grade. 7/15/15- 6) Triangular fragment and headstone drilled to receive two 1/2" fiberglass rods. Fragment and headstone pinned, the pins secured with Akepox 2010 Stone Epoxy. 8/25/15- 7) The plan was to mortar the repaired stone into its base. A test fit revealed that the stone was 1/4" too large for the slot. The bottom of the stone notched slightly. 8) Headstone mortared into its base with a lime based mortar of 3:2:8. 11/20/15- 9) Infill along break using Limework's St. Astier's Lithomex "Natural." 10) Area landscaped around stone.
