# Preservation Master Plan

Old Burying Ground Kingston, Massachusetts

2020

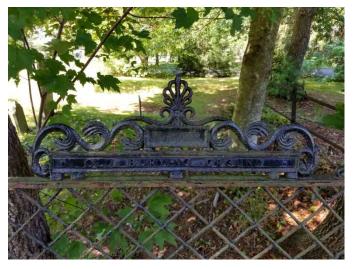
A crown on the top rail of the east gate marks the property at the "Old Burying Ground."

- Upgrade the east entrance by restoring the cast iron gate and fence panels and re-installing these on cleaned and straightened granite posts
- Upgrade the cast iron fencing and gates along the south edge by removing rust, straightening, and re-painting

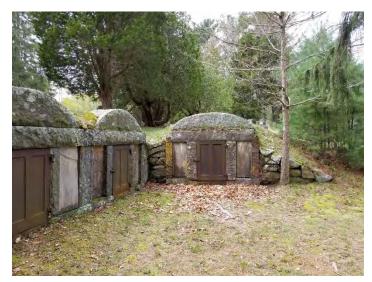
Four private tombs support the burying ground's north slope.

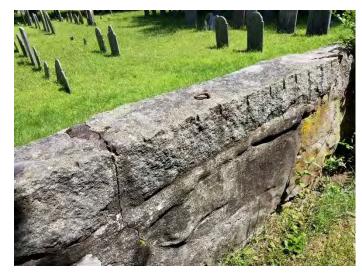
A parged granite block wall separates the burying ground from Main Street on the west side of the Church.

at the southwest corner and running eastward for approximately 132 feet. The wall acts as a retaining structure for the burying ground's southwest corner. As noted above, the remainder of the south edge is defined by the First Parish Church structure and adjacent cast iron fences.

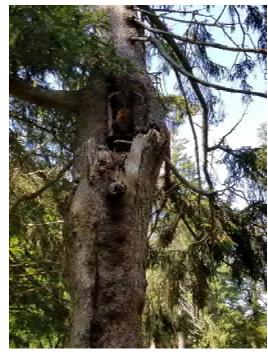
The burying ground contains 24 spruce trees, many of which are in decline. An animal (or bird) appears to have made a home in the cavity of this tree.

these trees should be cared for on a regular basis through pruning, feeding and where required, cabling. Thirteen trees are in fair condition, showing signs of decay. These should be monitored and removed as decay advances. Nineteen trees are either dead or in very poor condition, and these should be removed to avoid spread of disease and/or delimbing or altogether falling onto gravestones and monuments. The low-branching limbs (under 15' high) on trees that remain should be removed to allow light into the burying ground and open visibility across the landscape.

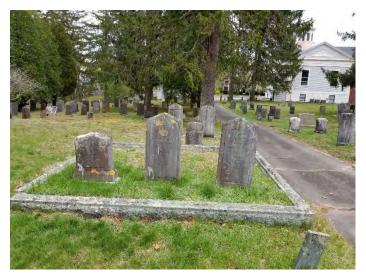
• Family Plot Enclosures. Granite curb or coping and granite posts have been used to outline the edges of seven family plots (5 curbs and 2 sets of posts) located in the northern half of the burying ground. While these are intact, some of the curbing sections have begun to overturn and several of the posts are leaning. The likely causes of both conditions are inadequate foundations and/or build-up of water in the soil underneath and/or behind the stones.

Granite curbs outline the edges of seven family plots within the burying ground, and several have begun to overturn. Build up of water in the soil and inadequate foundations are two likely causes.

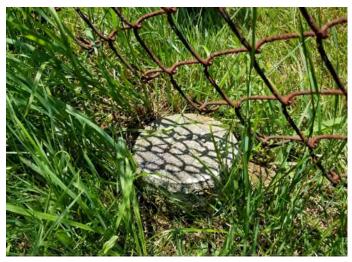
A set of concrete markers, numbered 1 - 18, lies approximately 15 feet apart along a portion of the west property line, presumably added to define a plot layout following acquisition of this land in 1838.

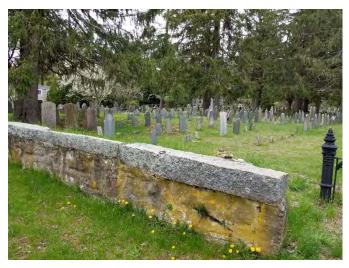
Granite block walls line both the east and south cemetery edges and portions of the walls act as retaining structures. Despite the age of the walls, they appear plumb, with only cosmetic deterioration.

parging has deteriorated in spots (cracked and worn away), and plants have taken root in some locations where parging is missing. Plants have also grown up along the base of the east wall. Portions of both walls act as retaining structures and both appear plumb with no signs of overturn, bulging or sliding. Deterioration appears largely cosmetic.

- Remove plant growth at the bases and within the joints of the perimeter stone walls, and clean the walls
- Stabilize the private tombs per the recommendations of the structural assessment
- Conserve the 660 +/- monuments and gravestones identified in the assessment as requiring treatment
- Re-set granite copings and posts surrounding family plots
- Unearth and re-set the concrete plot markers along the west boundary line
- Develop and install a sign program that identifies the burying ground and provides interpretive information for visitors (including reference to historic cart path)

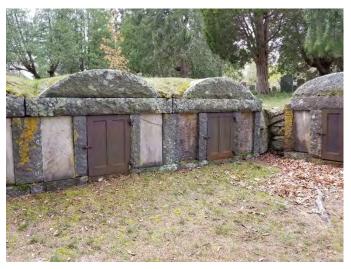
*Private Tombs.* A set of five private tombs were constructed into the burying ground's north slope in the early to mid 19th century. Visible dates of death on the tombs range from 1819 to 1868. The interiors were constructed with mortar-parged fieldstone, and each is faced with a brick front wall, granite door jamb, and granite sill and rests on a stone rubble foundation. Inspection of tomb interiors revealed that the side and back walls are in materially good condition, with some settlement cracks, spalls in the parging, and eroded joints. The earth-covered roofs consist of granite slabs headed by cut stone lintels and while some are intact, others have separated, allowing water

The five private tombs are built into the burying ground's north slope. While the interiors are materially sound, portions of the stone and brick work have deteriorated or failed.

and the pins have corroded. Recommendations for treating the tombs include re-pointing mortar joints; injecting grout into cracks; applying waterproofing to the roofs; replacing iron hardware with stainless steel. The front walls and rubble foundations of some will require dismantling and rebuilding. For a detailed assessment of the five tombs, refer to the *Old Burying Ground Mound Tomb Assessment*, found in *Appendix B* of this plan.

As discussed under the structural assessment, the condition of the five tombs supporting the north slope of the burying ground varies. Stabilization work will involve crack filling and joint repointing, waterproofing, and restoring one door. Because these structures abut one another, work on them will be most cost-effective if undertaken as one project, rather than five separate efforts.

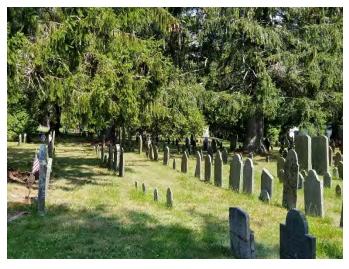
The Old Burying Ground is dominated by slate markers, many of them carved by local artisans. Many show signs of deterioration, including delamination, tilting, and breaking into fragments.

The assessment identified a total of approximately 660 +/- stones and six box tomb markers requiring conservation treatment. The urgency for treatment is high (priority 1) across all 660 +/- stones. Conservation problems include delamination (of slate), stones that have loosed on their pins, broken stones, tilted stones, and stones that have completely fallen. Significant biological growth covers many, and some stones have been repaired in the past with concrete. Causes of these deteriorated conditions at the Old Burying Ground are detailed in the *Gravestone and Monument Assessment (Appendix C)*; a summary is as follows:

The assessment recommends treatment approaches to each of the 660 +/- stones and six box tomb markers. Conservation measures include resetting, repairing with adhesive, mortaring into bases, tacking, capping/infilling, and stabilizing delaminations. In some cases, old repairs need to be removed, stones need to be re-pinned, and/or new bases/foundations are required. For a detailed description of all treatment recommendations, refer to *Appendix* C.

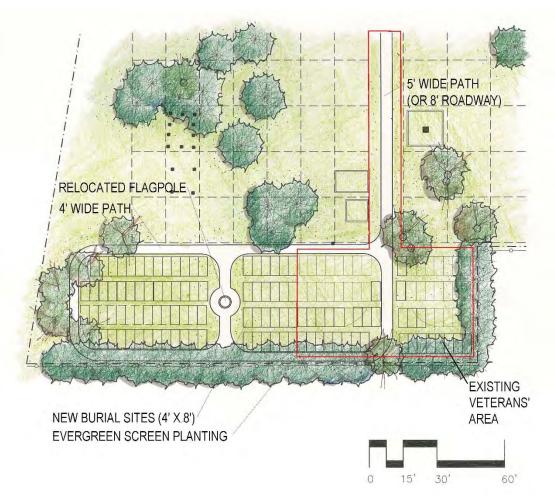
Project #4: Veterans' Area

This small area located at the northwest corner of the burying ground currently contains 41 burial sites, laid out in a grid around a flagpole. Access is via a 10' wide asphalt paved roadway leading from the east gate.

The northernmost portion of this area, approximately 4,800 SF, has not been developed. Project #4 involves an expansion of this area to include more as many as 100 additional burial sites, as well as an upgrade to the west cemetery edge through the removal and replacement of the chain link fence. The small round concrete plot markers along this edge will also be unearthed and reset. Narrowing of the existing asphalt roadway to path width (5' – 6') will take place as part of this project. (Alternatively, the roadway could remain, but should be narrowed to 8'). The area remaining could be used by the town for in-ground cremation burials along one or both sides of the former roadway. Note that unmarked graves may exist in this area. To make this determination, the town should undertake subsurface testing, prior to implementing the project. A columbarium structure may also be considered for this area however, the project, as defined, has not included this.

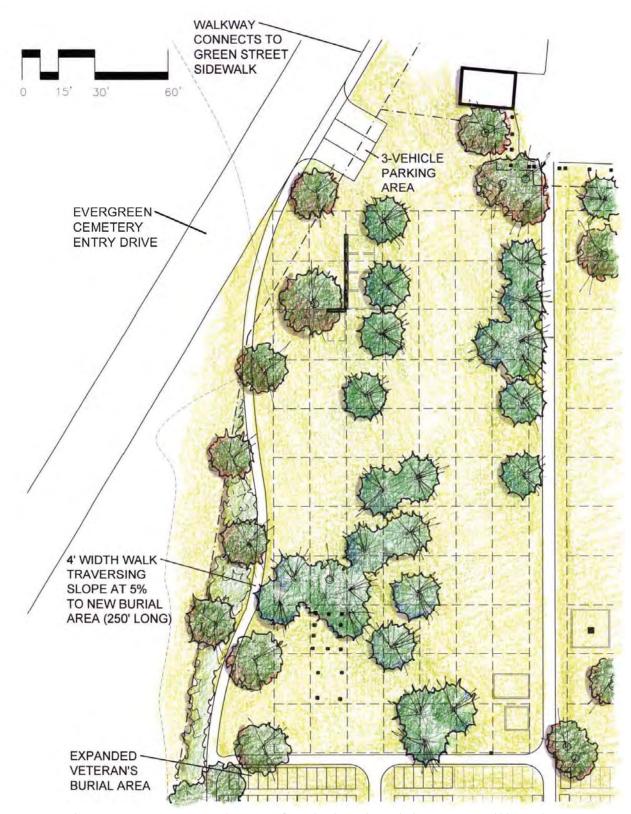
Project #7 involves creating a new entrance to the Burying Ground utilizing the north slope. Access would be via the Evergreen Cemetery entry drive, and entry into the burying ground would be via a gently curving and loping walk leading from a parking area to the expanded veterans' burial area.

The town does not maintain a parking for visitors to the burying ground separate from on-street parking along Green and Main Streets. To remedy this lack of parking, the town would create a new entrance and parking area along the burying ground's north slope, to be accessed via the Evergreen Cemetery entry drive (see graphic on next page). The parking area would contain up to three spaces, and from these a gently-graded, 4' wide walkway would traverse the north slope. Because of the steep grade in this area, the walk would need to extend approximately 250' in order to adhere to ADA regulations. The walk would connect to the new pathway created in the Veterans' Area (see Project #4). Shade trees and slope-stabilizing woody plants would edge the new walk.
