Organization <u>Kingston Historical Commission</u> Date (month/year) <u>March 2002</u>

KIN.452	
number USGS Quad Area(s) Form Number	
Plymouth B 452	
Town Kingston	
Place (neighborhood or village) Main Street	
Address 263 Main Street	
Historic Name	
Uses: Present residence	
Original residence	
Date of Construction 1902	
Source Assessor's Office files	
Style/Form vernacular	
Architect/Builder	
Exterior Material:	
Foundation brick	
Wall/Trim wood clapboard	
Roof asphalt shingles	
Outbuildings/Secondary Structures garage 1981	
Major Alterations (with dates)	
·····	
Condition good	
Moved Into I yes Date	-
Acreage 43,522 sf	
Setting DEC 14 200	5
linear neighborhood, main Street, near intersection	17.54

MHC INVENTORY FORM CONTINUATION SHEET *MHC Inventory scanning project, 2008-2012*

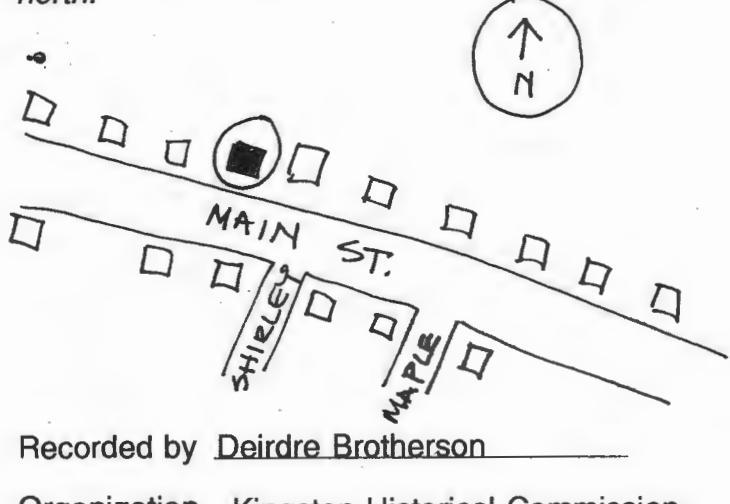
The residence at 263 Main Street was built in 1902 in the vernacular style with a front gable roof. This 3 x 4 bay, wood frame, two story building is rectangular in plan and sits on a brick foundation. The building is clad with wood clapboards. The front gable roof is covered with asphalt shingles. One brick chimney is located on the rear slope of the roof. The off-center entrance contains a wood door with a glass panel flanked by a sidelight on one side with a plain surround. The windows contain vinyl replacement sash with flat surrounds and a molded cap. The cornerboards are thin and flat. The cornice is thin with a shallow molding. The windows on the side elevation have been altered and condensed into one large window.
