SLEAN		KIN.233
er USGS Quad	Area(s)	Fo 233	orm Number
PIT		200	
Town Kingston			
Place (neighborh	ood or vil	lage)	
Address <u>116 Elr</u>	n Street		
Uses: Present r			
Date of Construct			
Source maps			
Style/Form - Gele	nial Revi	/al-co	ttage
Architect/Builder			
Exterior Material:			
Foundation rusti		vrete nentt	lock
Wall/Trim wood	clapboar	rds	
Roof wood shing	les		
Outbuildings/Seco	ondary St	ructur	res
garage			
Major Alterations	(with date	es)	
Condition good			
Moved 🛛 no 🗌	yes [Date	
Acreage <u>1 acre</u>

BUILDING FORM

INVENTORY FORM CONTINUATION SHEET	Community Kingston	Property Address 116 Elm Street	KIN,233
Massachusetts Historical Commission 220 Morrissey Blvd. Boston, Massachusetts 02125		Area(s) FormNo.

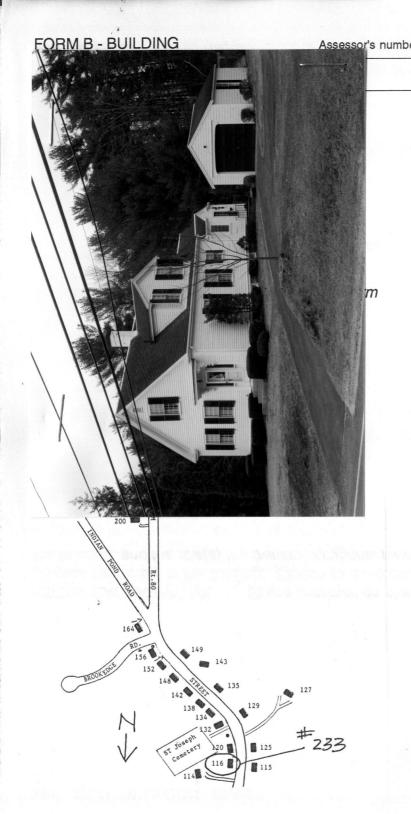
The residence at 116 Elm Street was built c. 1900, a cottage in the Colonial Revival style: This 3x4 bay, wocd frame, 1-1/2 story building sits on a rock-faced cement block foundation. The building is clad with wood clapboards. the front gable roof is covered with wood shingles. A brick chimney is located in the center at the ridge, The sidehall entrance contains an early 20th century wood door with a large square glass pane in the upper section. The door is flanked by half sidelights and protected with a door hood supported by scroll brackets. The windows contain 12/12 wood sash with flat surrounds. A dormer projects from the east roof slope. The rear ell contains a secondary entrance. A single stall, front gable garage is located next to the house.
