Town Kingston

Address 120 Summer Street

Historic Name A. Hammond House

BUILDING FORM

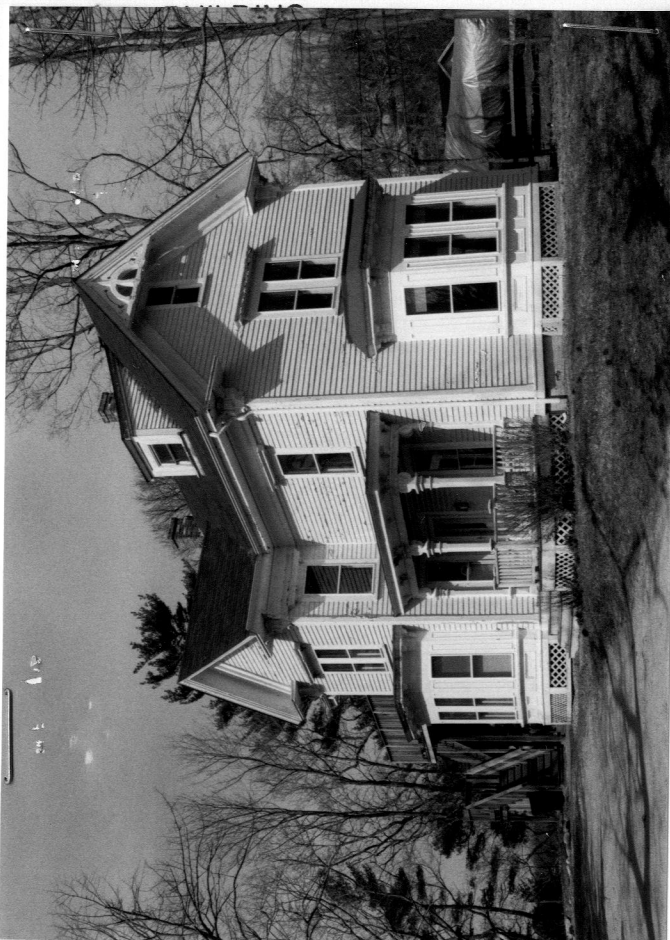
The residence at 120 Summer Street was built c.1878 in the Italianate style. This 3x4 bay, wood frame, 2 story building sits on a brick foundation. The building is clad with wood clapboards. The front gable roof is covered with asphalt shingles. Two brick chimneys are located at the roof ridge. The entrance is located on the south elevation. The entrance contains an Italianate style door with paired round arch glass lights. The entrance is covered by a one story open porch with a flat roof. The porch roof is supported by chamfered posts with Egyptian capitals and brackets at the porch cornice. The windows are mixed with 1/1 sash single and paired windows all of which have bracketed hoods. Bay windows project from each elevation and are also enhanced with brackets at the cornice. The cornerboards are thin and flat. The cornice is boxed with returns. A decorative verge board enhances the front gable.
