FORM B - BUILDING

Town Kingston

Address 67 Main Street

BUILDING FORM

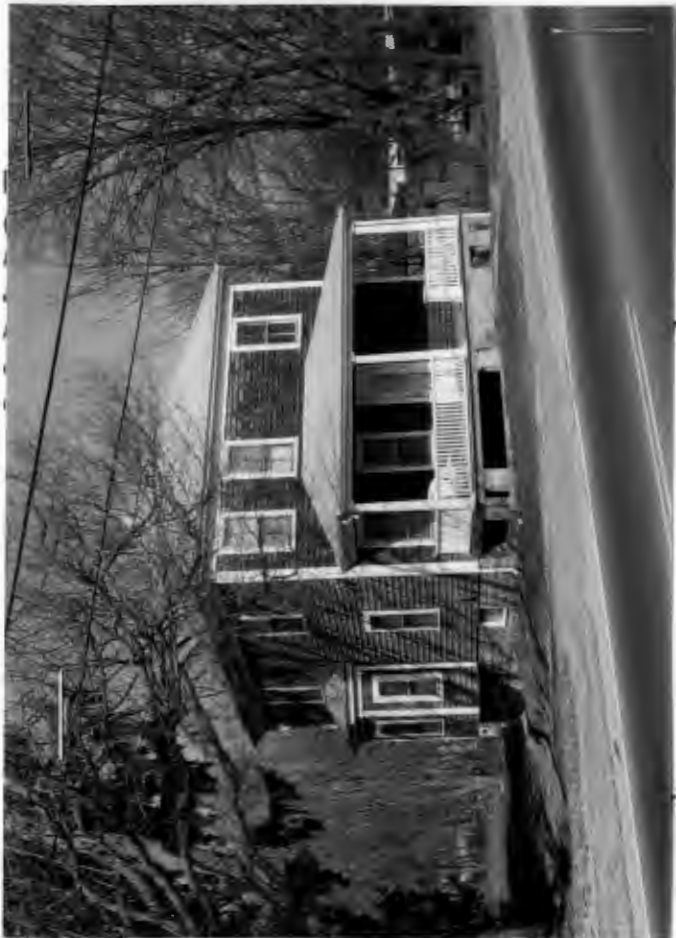
Style/Form American Foursquare

Foundation rusticated cement-block

Wall/Trim wood shingles

Roof asphalt shingles

Condition good

The residence at 67 Main Street was built c.1900 as an American Foursquare. This 3x3 bay, wood frame, 2 story building sits on a rusticated cement block foundation. The building is clad with wood shingles. The hip roof is covered with asphalt shingles. A brick chimney is located in the center of the building. The entrance is off-center and contains a early 20th century wood door with a large glass pane in the upper section. The windows contain 2/2 sash. The corner boards are thin and flat. the cornice is boxed. A hip roof open porch runs across the facade of the building and is supported by Doric columns. A bay window projects from the west elevation.
