KIN.446

Address 236 Main Street

Style/Form Gambrel - Colonial Revival

BUILDING FORM

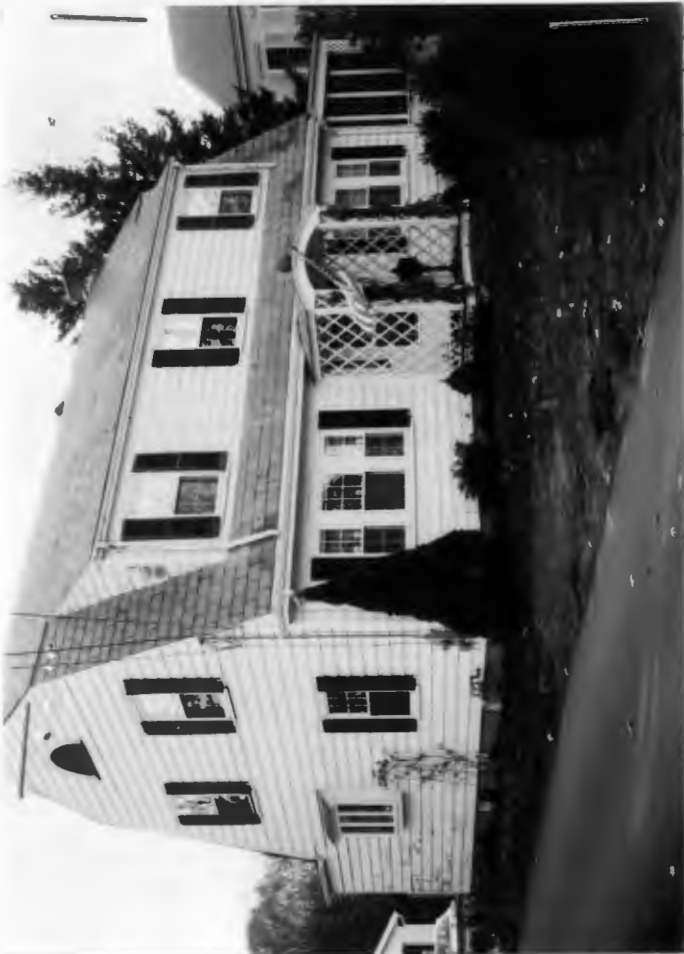
The residence at 236 Main Street was built in 1924 in the Colonial Revival with a gambrel roof. This 5 X 2 bay, wood frame, two story building is rectangular in plan and sits on a concrete foundation. The building is clad with wood shingles. The gambrel roof is covered with asphalt shingles. A shed dormer projects across the front of the building and contains three single windows. One brick chimney is located on the side, exterior of the house. The entrance contains wood door flanked by half sidelights with a plain surround. The entrance is protected by a arched porch with and open trellis on the sides. The windows contain 6/6 vinyl sash with flat surrounds. A half-circle window is in the side gable The cornerboards are thin and flat. The cornice is thin with a shallow molding. A one story 3-season porch is attached to the side of this building. It has a flat roof and open sides.

A garage built in 1981 sits to the rear of the building.
