KIN.448

s number _____ USGS Quad Plymouth Area(s) B Form Number 448

Town Kingston

Address 243 Main Street

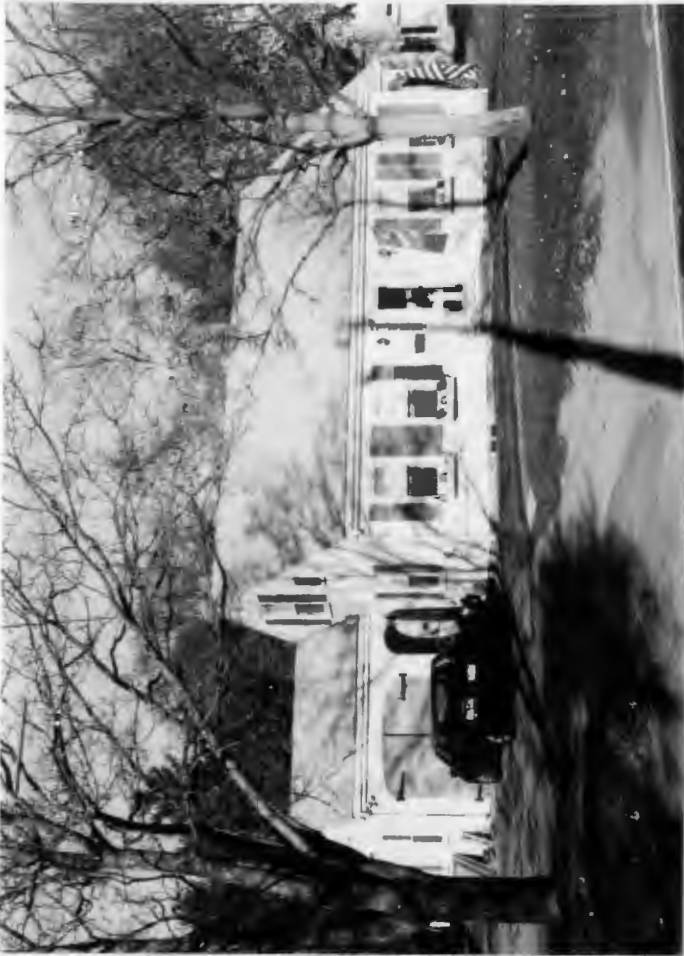
The residence at 243 Main Street was built in 1910 in the Cape style with a side gable roof. This 5 x 2 bay, wood frame, one-and-a-half story building is rectangular in plan and sits on a concrete foundation. The building is clad with wood clapboards. The side gable roof is covered with asphalt shingles. One brick chimney is located in the center of the house. The center entrance contains a wood panel door flanked by half sidelights with a molded surround. The windows contain 6/6 vinyl sash with molded surrounds. The cornerboards are thin and flat. The cornice is thin with a shallow molding.

A one stall garage is attached to one side of the building. It contains an arched opening with double doors opening outwards. A one story room with a recessed porch is attached to the other side elevation.
