KIN.453

Town Kingston

Address 265 Main Street

MHC INVENTORY FORM CONTINUATION SHEET

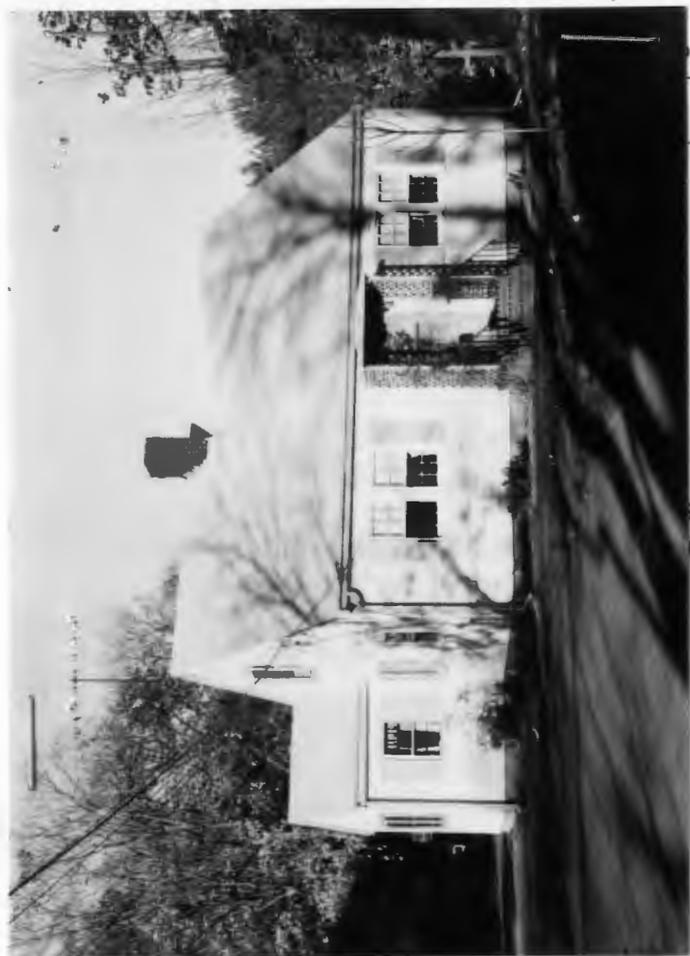
The residence at 265 Main Street was built in 1948 in the cape style with a side gable roof. This 3 x 2 bay, wood frame, one-and-a-half story building is rectangular in plan and sits on a concrete block foundation. The building is clad with wood shingles. The side gable roof is covered with asphalt shingles. One brick chimney is located in the center of the house at the ridge. The entrance contains a wood door with a plain surround. The door is protected by a door hood supported by a posts and a trellis. The windows contain 6/6 sash with flat surrounds. The cornerboards are thin and flat. The cornice is thin with a shallow molding. A small room is attached to the side of the building.

A garage and workshop are at the rear of the property.
