or's number \_\_\_\_\_ USGS Quad Plymouth Area(s) B Form Number 457

Town Kingston

Address 280 Main Street

MACRIS No. KIN.457

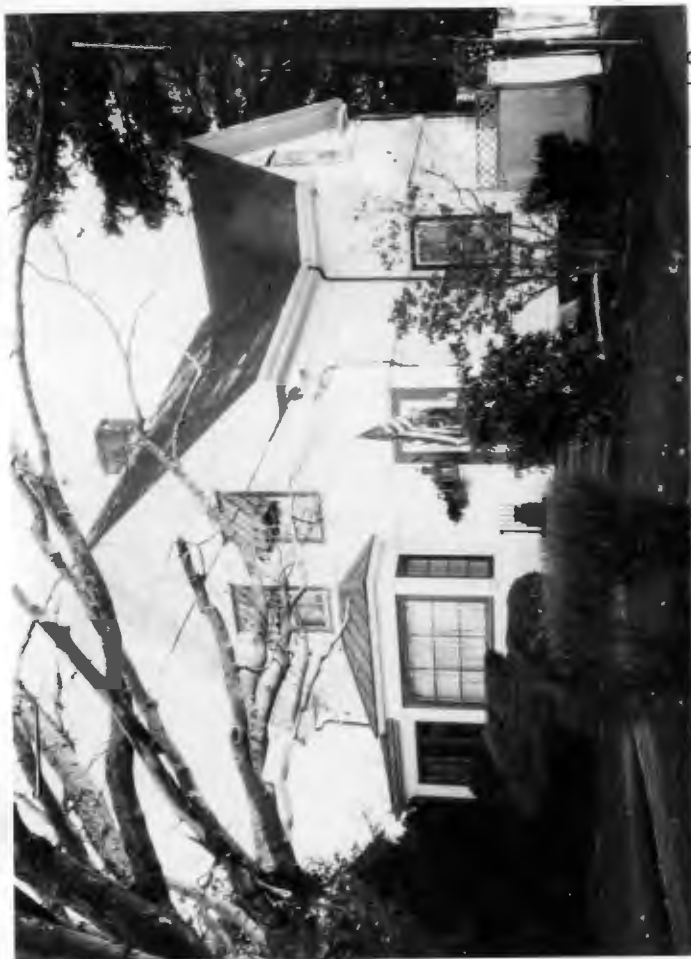
Condition good

The residence at 280 Main Street was built in 1897 in the vernacular style with a front gable roof. This 3 x 4 bay, wood frame, two story building is rectangular in plan and sits on a brick foundation. The building is clad with wood clapboards with scalloped shingles in the gable. The front gable roof is covered with asphalt shingles. One brick chimney is located in the center of the house at the ridge. The off-center entrance contains a wood door with a plain surround. The windows contain 2/2 wood sash with molded surrounds. A bay window projects from the facade, next to the entry. The cornice is thin with a shallow molding. A side ell is attached towards the rear of the building. A shed roof porch, part of which is enclosed, wraps around the side and front ell of the building.

This building was built c. 1897. It is similar in design to the building at 282 Main Street. This building has had more alterations than the 282 Main Street building. It appears that the door hood has been removed, the porch has been enclosed, and the windows have been altered. This is a common building form found in many towns on the south shore and in most communities with a good supply of late 19th century vernacular buildings. The plan most likely came from a plan book and was duplicated by the same or different builders all over town.

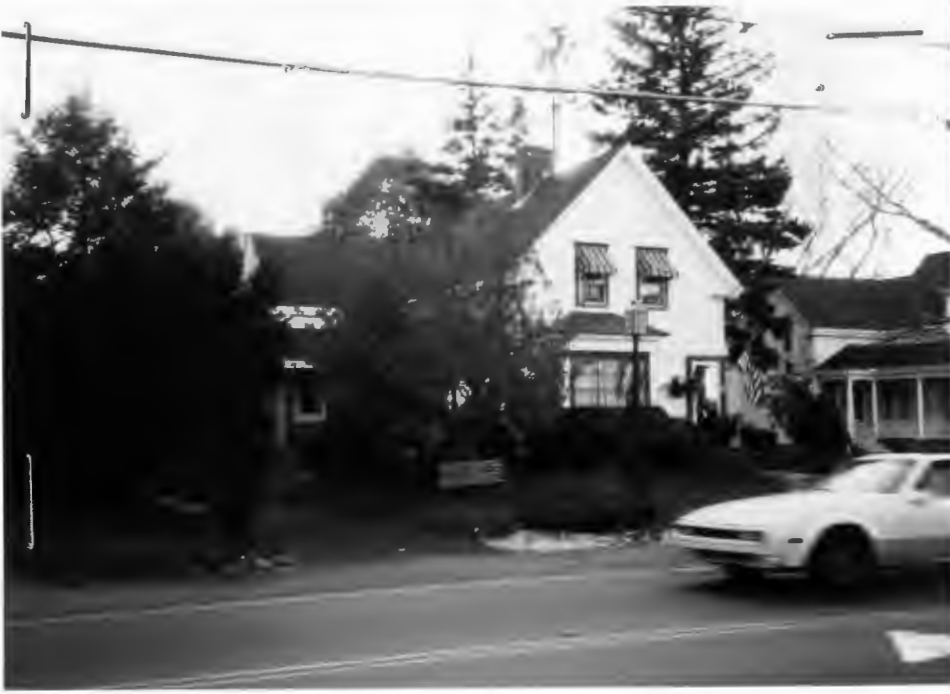
A garage is located toward the rear of the property.
