FORM B - BUILDING

Town Kingston

Address 166R Main Street

KIN.322

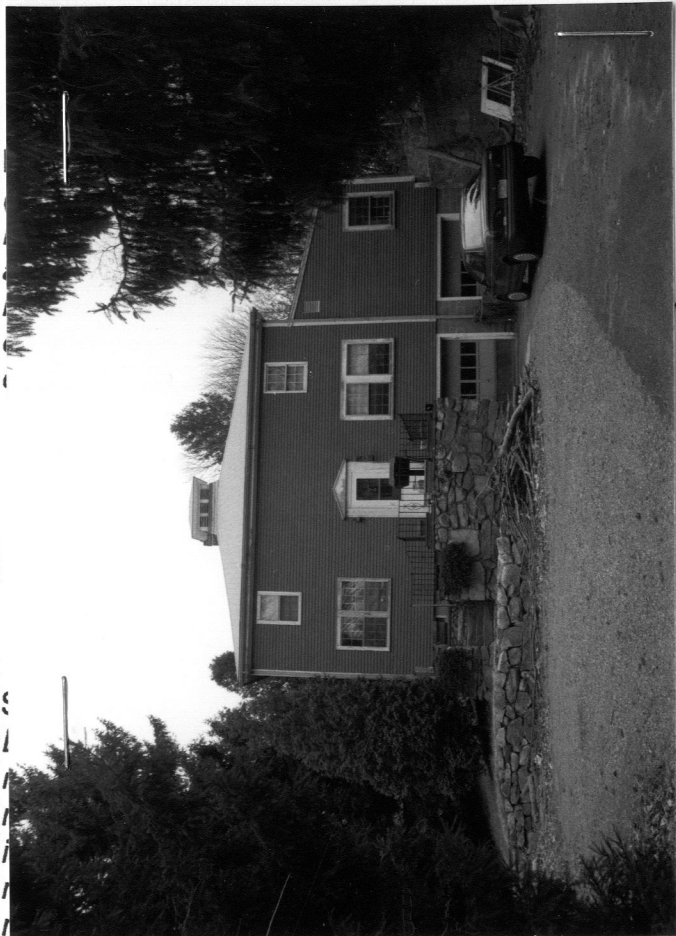
The residence at 166R Main Street was originally a c.1850 carriage barn converted to a residence. This 3x3 bay, wood frame, 2 story building sits on a concrete block foundation. The building is clad with wood clapboards. The hip roof is covered with asphalt shingles and a wood ventilator projects from the center of the roof. A brick chimney is directly behind the ventilator. The entrance contains a early 20th century wood door flanked by fluted pilasters and pedimented hood. The windows contain 8/8 sash on the first floor with 6/6 sash on the second floor with flat surrounds. A side addition to the building is covered by a shed roof.
